MILL POND DAM

MA. 00161

PHASE I INSPECTION REPORT
NATIONAL DAM INSPECTION PROGRAM

DECEMBER 1980

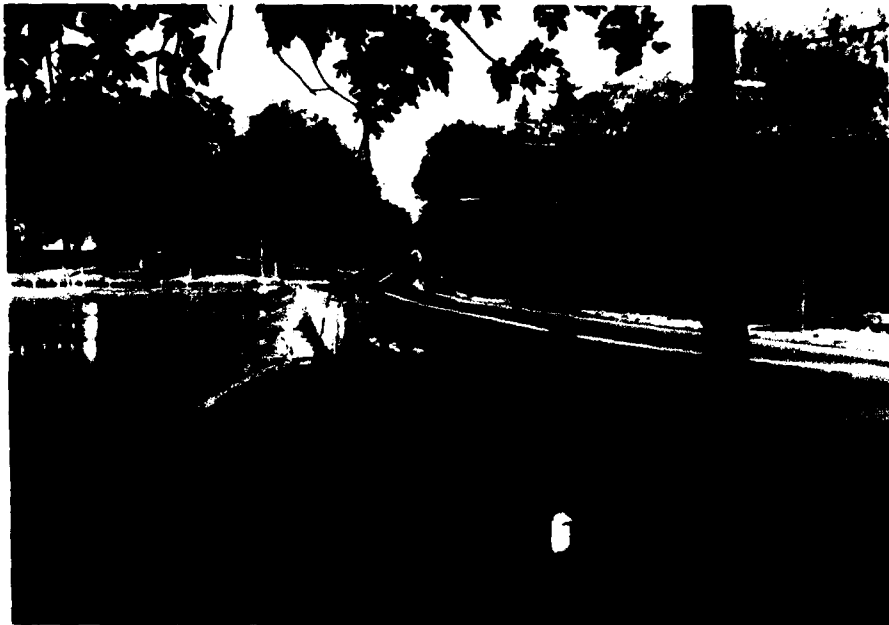
1. Upstream slope and crest of dam from right abutment.

(1) Repair minor erosion of the embankment at the upstream end of both spillways, using a suitable compacted fill for this purpose, and re-establish and maintain a protective growth.

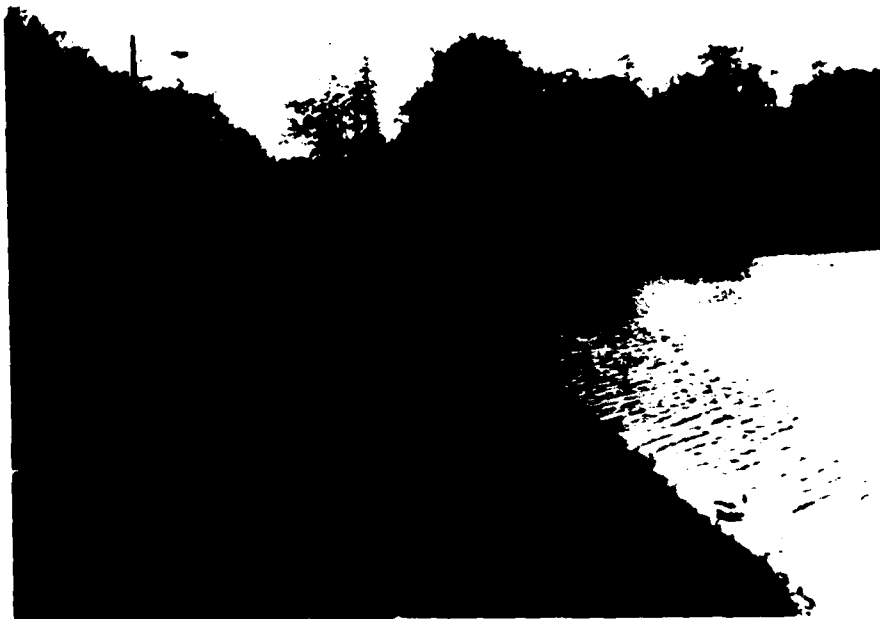
2. Upstream slope and crest of dam from left abutment.
